Department of Administration
Construction Update No. 49
March 14, 2005

Scaffolding Surrounds Small Dome and Eagle at Top of Capitol Building

Uncovering Multiple Layers of Silver Paint, Coatings From Small Dome May Reveal Sandstone Exterior

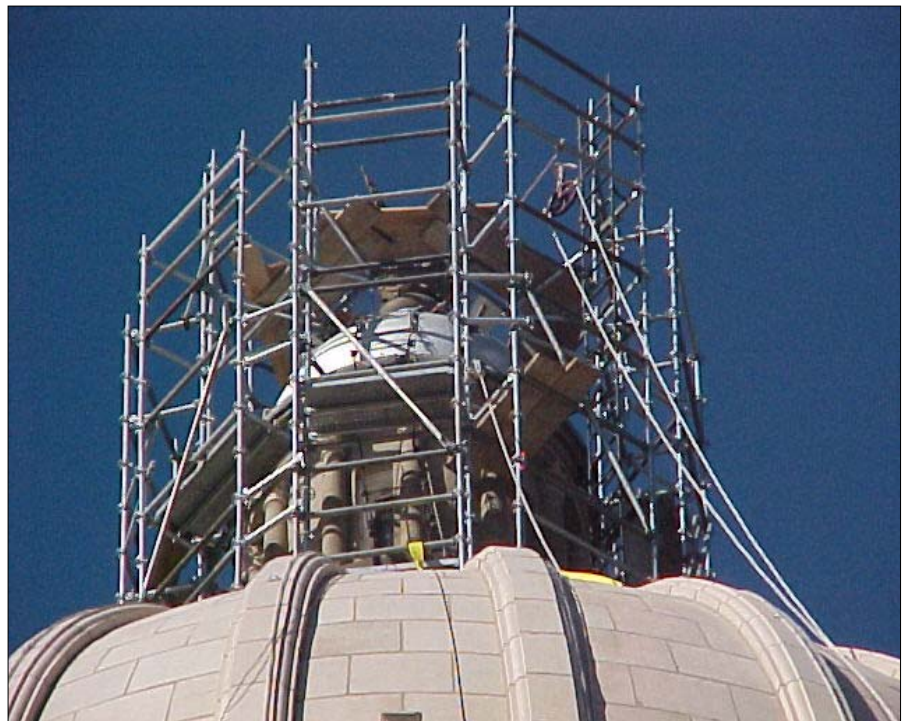
All the layers of existing paints and coatings will be removed down to the original substrate on the small dome directly underneath the eagle, Jan explained. "Initial scrapings indicate the small dome just may be made out of sandstone. We'll keep everyone posted," she added. The surface of the small dome will be thoroughly cleaned and a new watertight, elastomeric coating will be applied.

Work is also being done on the eagle. Several corrosion holes and cracks will be repaired. The entire surface will be cleaned, tarnish will be removed and the finish will be restored to a satin bronze. A protective wax coating will then be applied. The eagle is made of copper and is bronze-plated. It is perched atop the 26 foot lantern which is at the top of the dome proper. Including the triple pedestal of sandstone, the eagle measures 5 feet, 7 inches high.

Scaffolding surrounds the small silver dome at top of the Lantern Level on the Idaho Capitol Building.

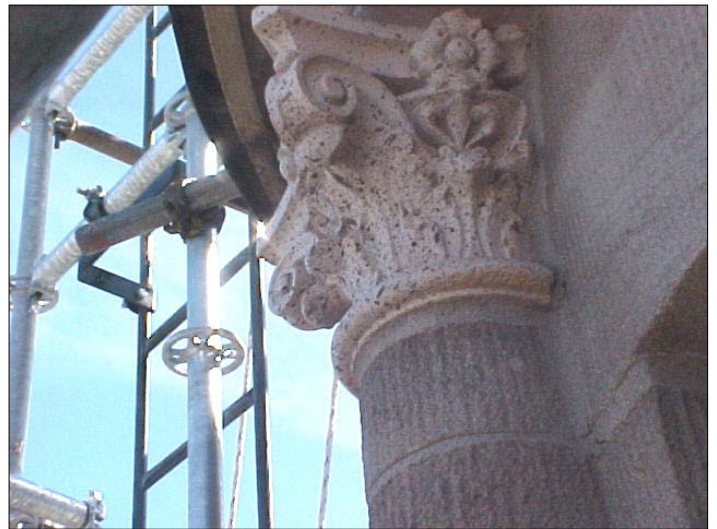
The lantern is constructed of sandstone walls and surrounded by several sandstone columns that will have repairs made to cracked and spalling areas.

Sandstone columns surround the lantern walls, both need repairs to cracked and spalling areas.

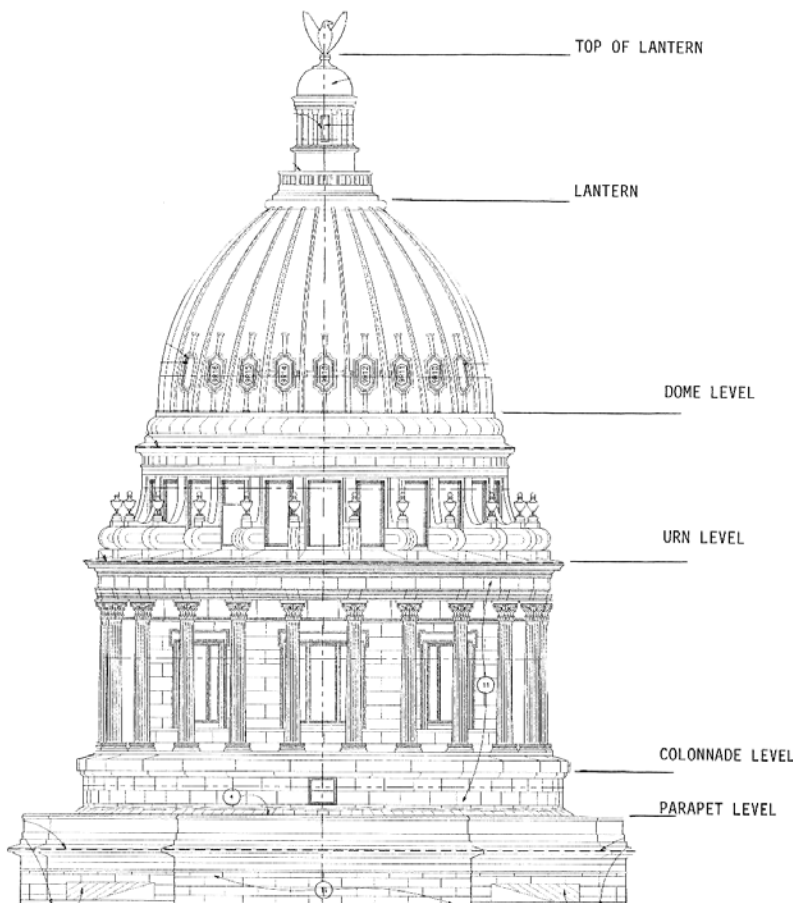
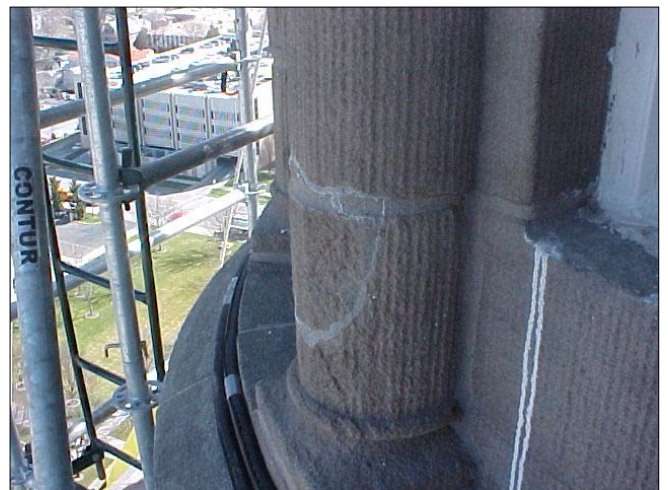
Existing mortar repair work requires correction. (Photos by Joe Rutledge, DPW)
